Maintaining flight

Africa's busiest airport, Johannesburg's OR Tambo International Airport, ranks among the best in the world. This is all thanks to the Airports Company South Africa and the engineers involved.

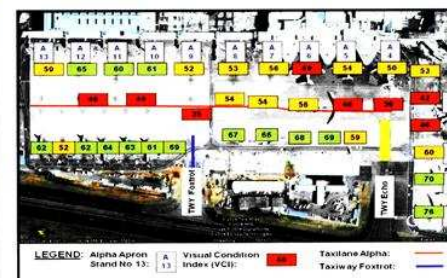
FIGURE 2 (Below) The aircraft bays A1 to A13, the latter being the oldest, and the taxi lane

Group 1 stands (red): Poorly performing stands with low visual condition indices (VCIs) and/or high deflection values. These include stands A2, A3, A4, A5, A6 and A13, which are in need of urgent repairs to accommodate current traffic safely.

Group 2 stands (orange): Stands with a lower intensity of distress (more sporadic) and medium deflection. The visual condition index for stands A7, A8 and A9 are not promising and, in addition, it has been found that for stand A9, a remaining structural capacity of not more than eight years should be expected.

Group 3 stands (green): Stands with only isolated distress. These include stands A10, A11 and A12, which do not indicate a risk of FOD at the moment, and deflection tests indicate a possible remaining capacity of more than 10 years.

- replacing the current (failed or weak) concrete slabs (and support layers) in areas affected by aircraft loading
- crack sealing and/or partial slab reconstruction for minor pavement damage
- sub-sealing of concrete pavements (identify and fill erosion voids where concrete panels have as yet not failed)
- providing surface and subsurface drainage systems to remove subsurface moisture and prevent surface water from crossing trafficked areas
- repairing joints, including partial depth concrete repairs and sealing of all joints on the apron, to reduce the ingress of water into the concrete support layers
